# FINAL REPORT

Project Title: P53: Effects of Wide Centre Line Treatment on Pavements Y1 & Y2 (2015/16 & 2016/17)

ARRB Project No: PRP16038

Client: Queensland Department of Transport and Main Roads

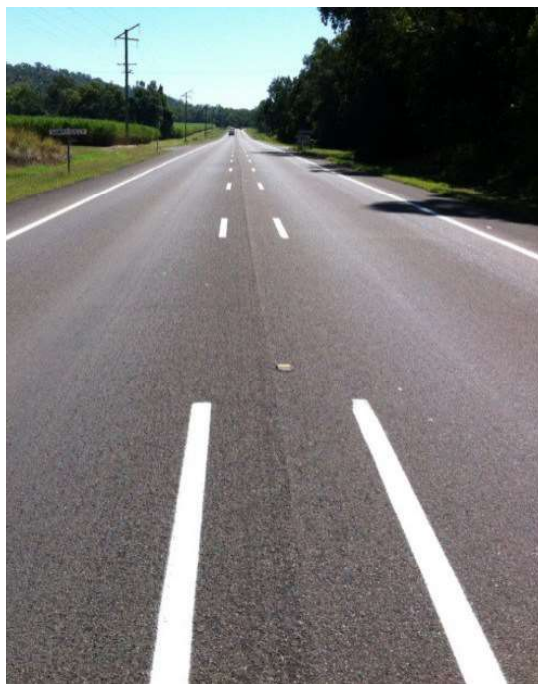
Figure 1.1: Example of a typical wide centre line treatment

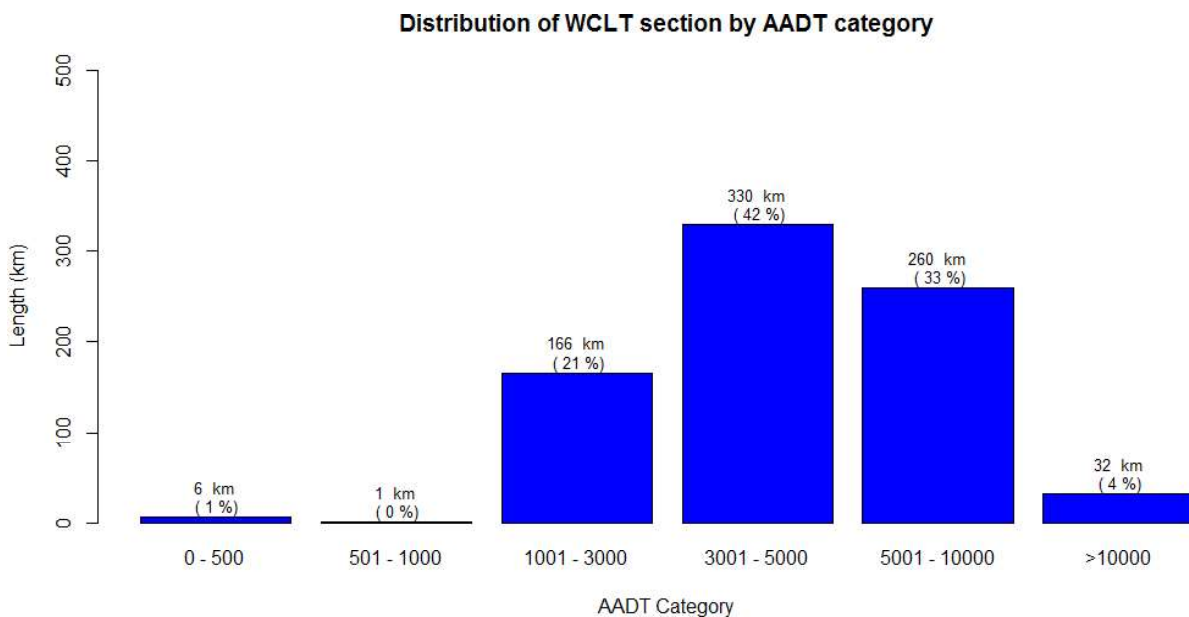
Figure 3.3: Distribution of WCLTs by average annual daily traffic (AADT)

The distribution of WCLT sections across the Districts and the associated traffic volumes is also shown in Figure 3.2 and Figure 3.3. The Mackay/Whitsunday District has the longest total length of WCLTs, totalling 231 km. The Fitzroy District also has a considerable length totalling 215 km that has the treatment. WCLTs have mainly been implemented on two-way, two-lane rural highways in 100 km/h environments, with traffic volumes greater than 1000 vehicles per day. One-third of the WCLT sections have traffic volumes more than 5000 vehicles per day.

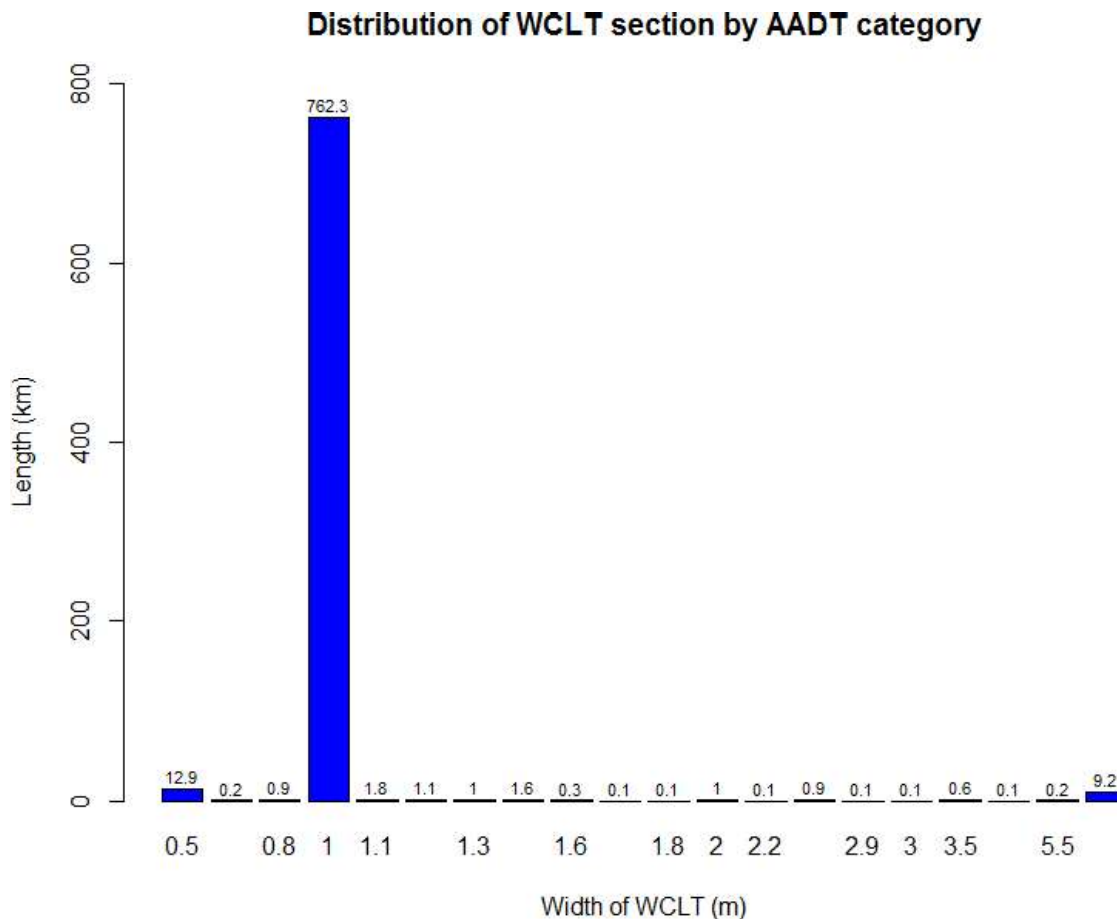
Figure 3.4: WCLTs width distribution

Figure 3.4 presents the distribution of WCLT width according to the ARMIS data provided. It shows that 762 km (96%) of WCLTs are consistent with TN155 by providing a 1m width. In the remaining 4%, the widths range from 0.5 m to 3.5 m.

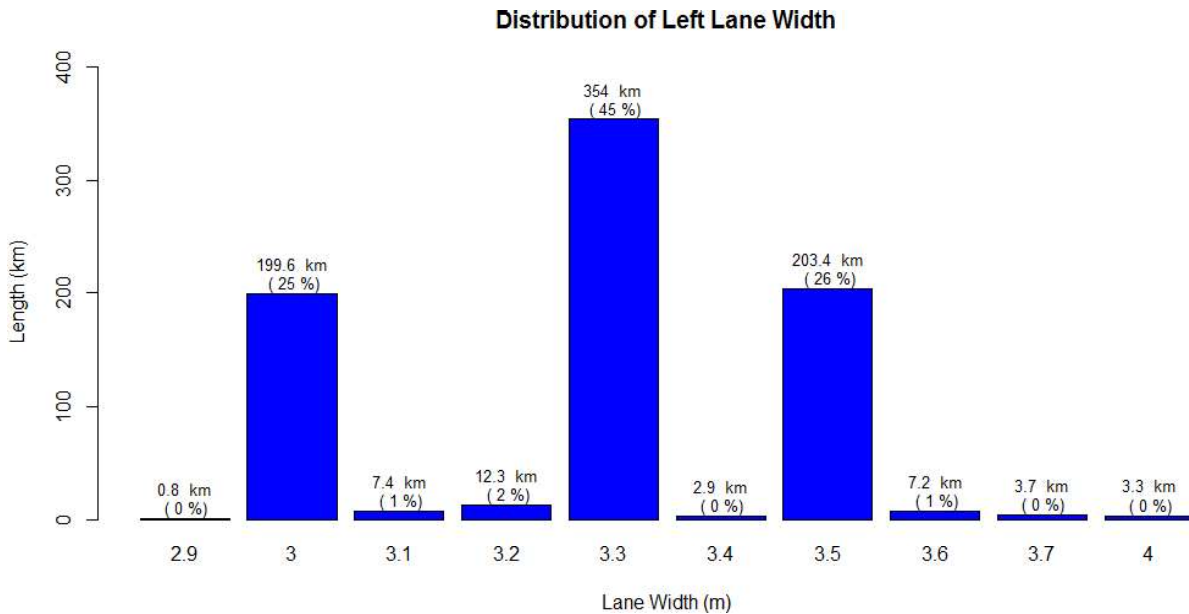
Figure 3.5: Lane width distribution along WCLT sections

A summary of the lane widths and shoulder widths along WCLT sections is provided in Figure 3.5 and Figure 3.6. It shows that the lane widths vary between 2.9 and 4.0 m, with the following distribution:

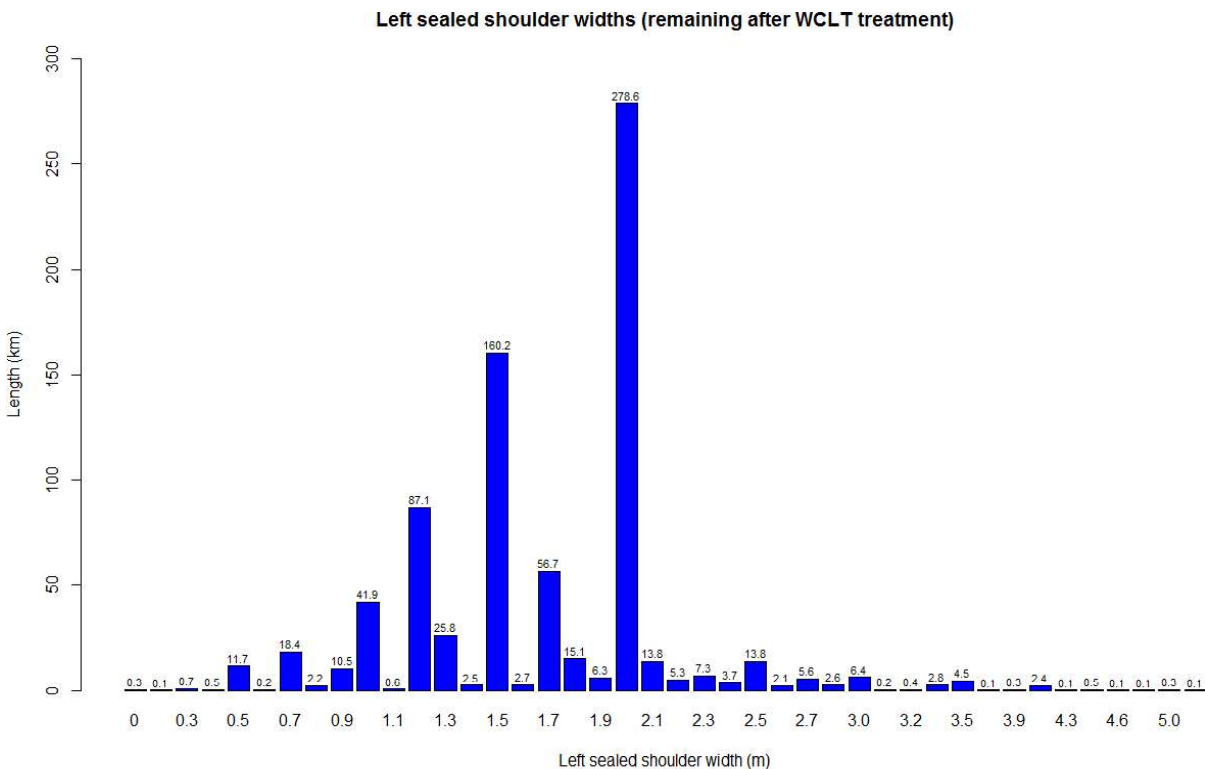
Figure 3.6: Sealed shoulder width distribution along WCLT sections

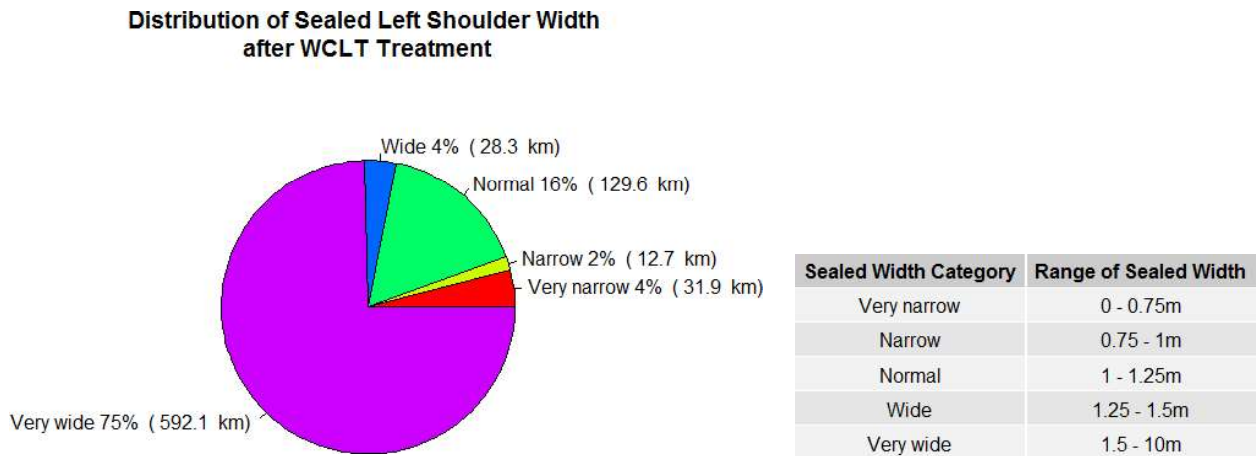
Figure 3.7: Distribution of sealed shoulders by category

Figure 3.7 shows the distribution of the sealed left (outer) shoulder width along the WCLT sections. The data is summarised by grouping the different sealed widths into descriptive categories (i.e. very narrow, narrow, normal, wide and very wide). The majority of the sealed width exceeds 1.5 m after the implementation of the WCLT.

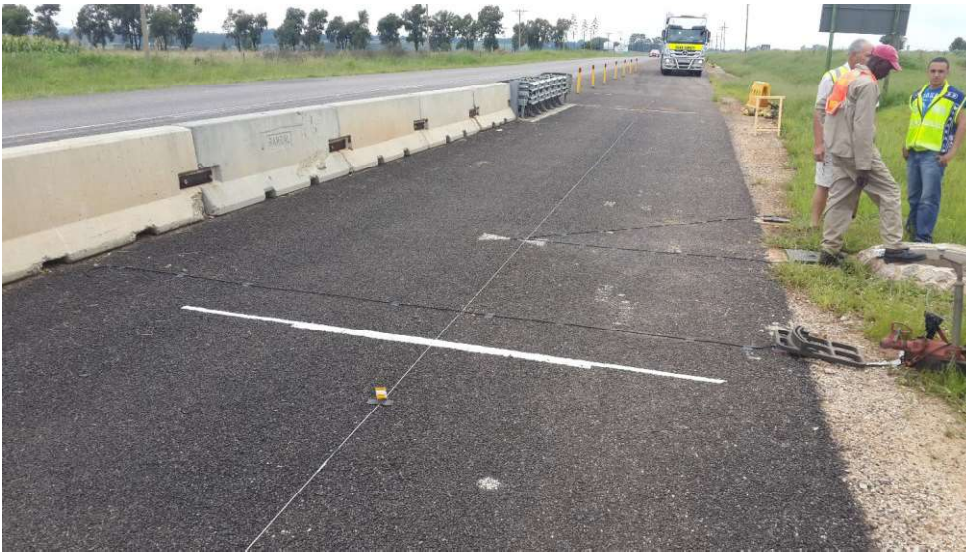
Figure 5.1: Example of the use of traffic-counter tubes to determine wheel wander in South Africa.

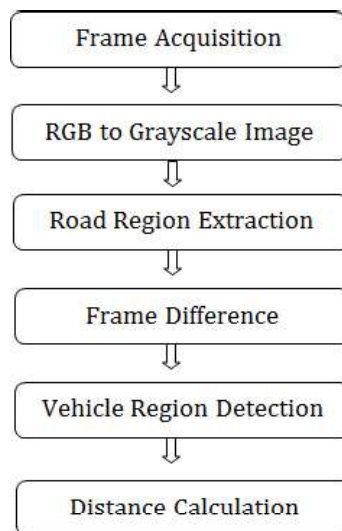
Figure 5.2: Image processing technique adopted in the study

Illustration and sample images for the different image processing steps is shown in Table 5.2. A detailed discussion of the image processing technique can also be found in the CQU research report included in Appendix E.

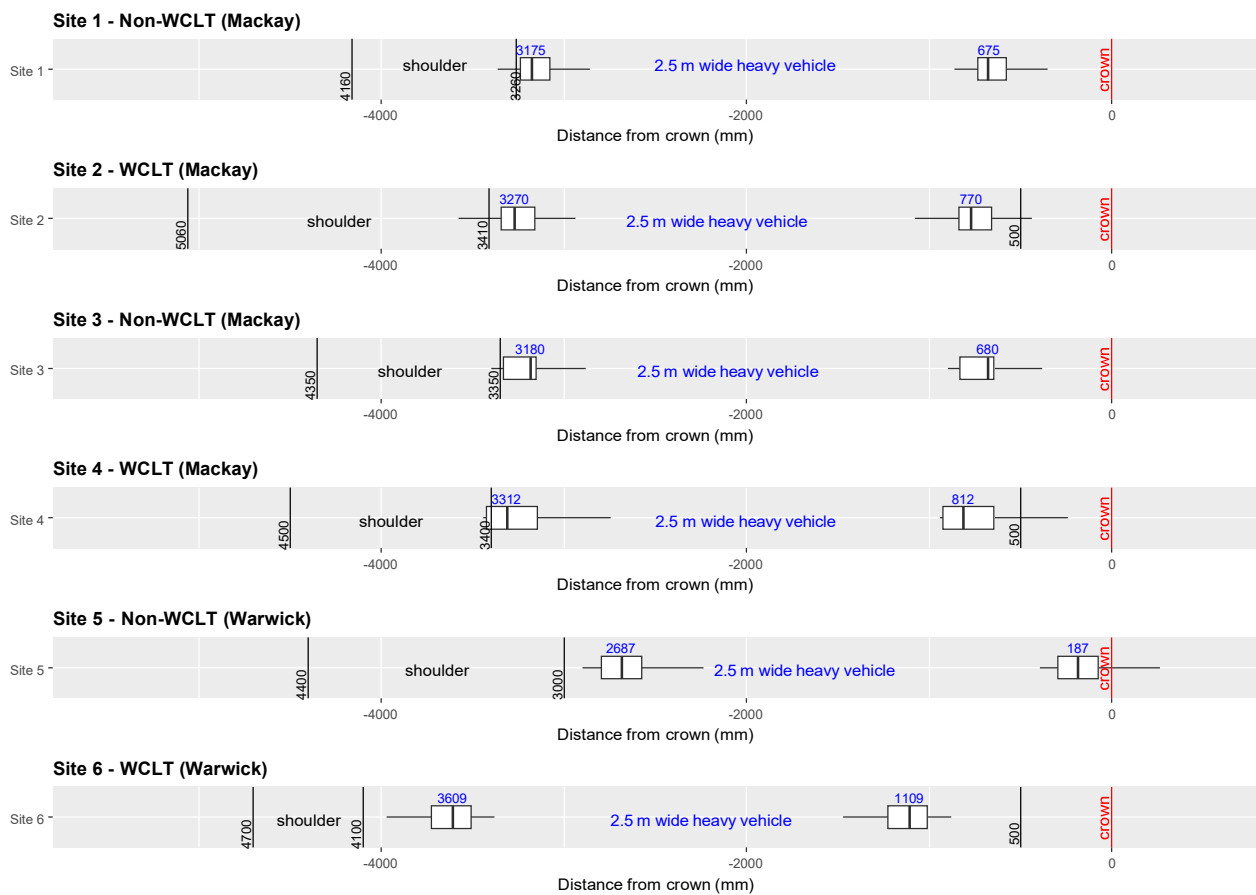
**Figure 5.8: Wheel positions and distance from the road crown**

The data suggests that, as commonly expected, all WCLT sections have the right edge of the wheel travelling further away from the crown. This can be partially explained by the additional 0.5 m width provided by the WCLT. The difference is significant between Site 5 and Site 6, but this can be caused by the significant difference in lane width and the fact that the data collected at Site 6 is at the start of a taper leading to a left-hand slip lane.

For Mackay, the average median distance between the crown and the outer edge of the right wheel for the non-WCLT sections is 678 mm. On the other hand, the average median distance for the WCLT sections is 791 mm. The difference is only 113 mm and is insignificant in relation to the tyre width.

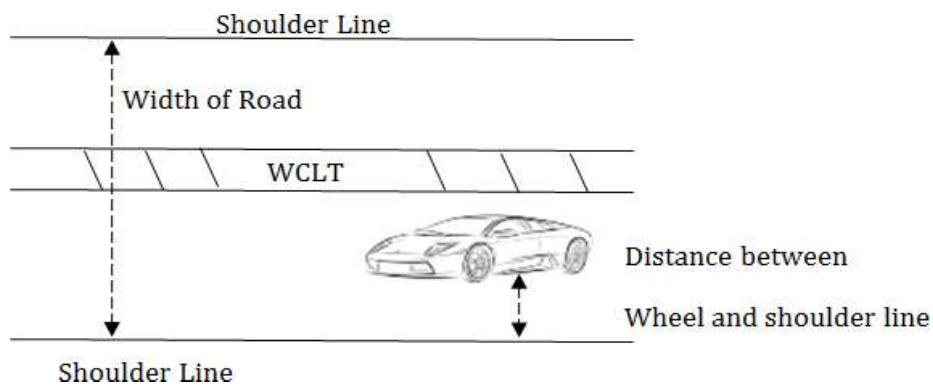
Fig. 3. Geometrical Street Model Encompassing Vehicle and Shoulder Line

The proposed framework is presented in this section. Figure 3 shows the geometric model for our target area. A sketch of the vehicle shows the movement of the vehicle. The captured images in this research were taken by a video camera.

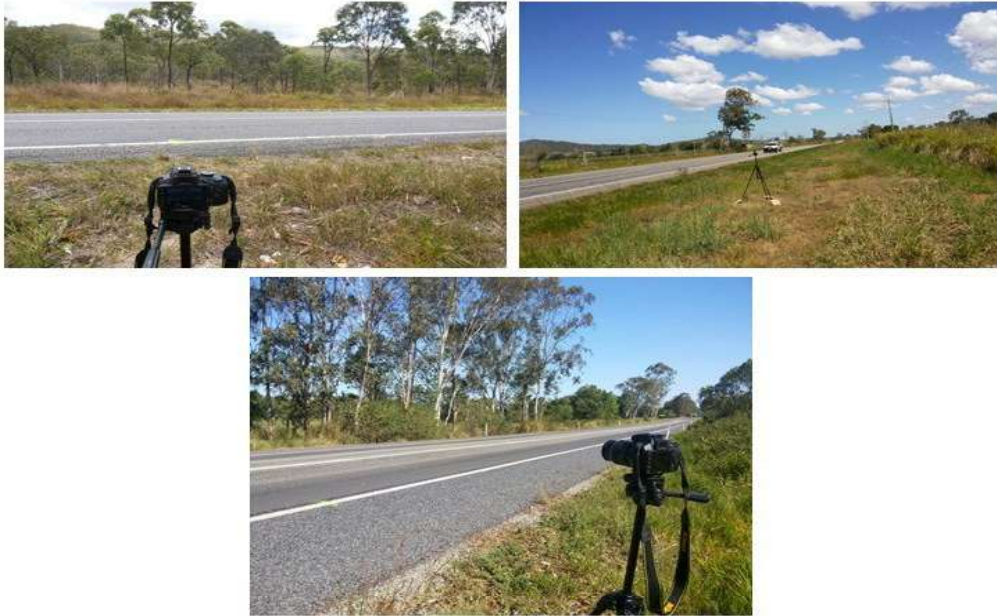
Fig. 6. Camera Setup (Nikon)

Figures 6 and 7 below show some examples of camera setup in the surveyed locations.

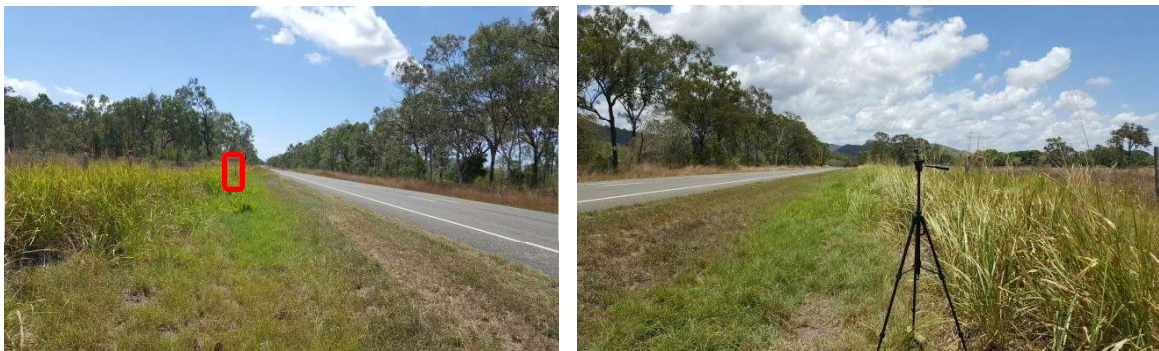
Fig. 7. Camera Setup (GoPro)

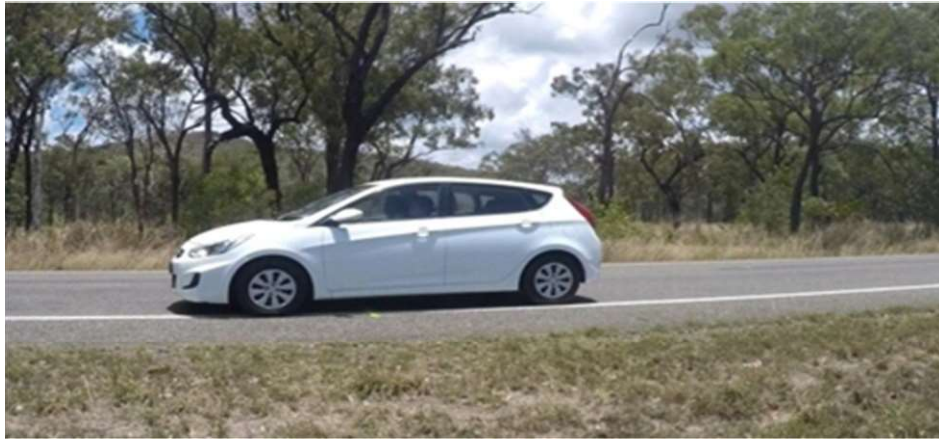
Fig. 8. Vehicle Covered within One Frame

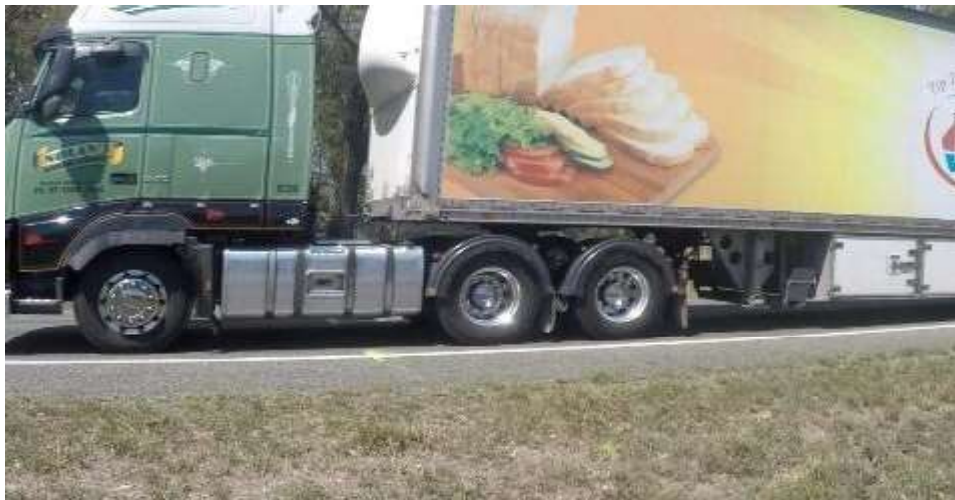
Fig. 9. Vehicle not Visible within One Frame

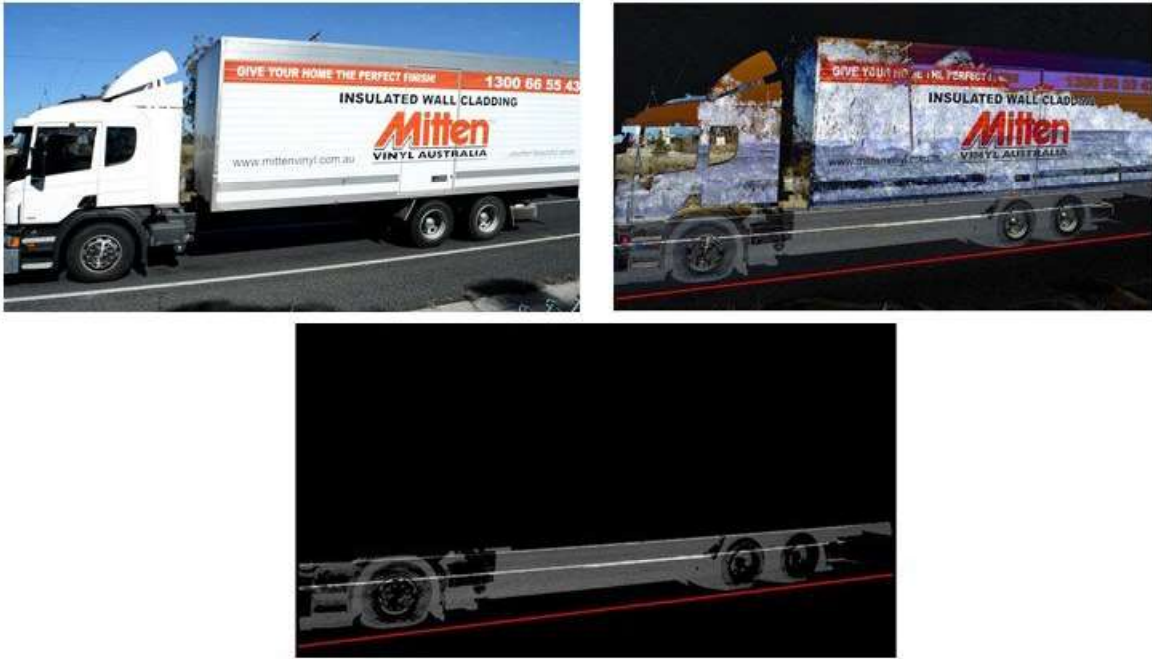
Fig. 13. Distance Calculation from Shoulder line to Wheel

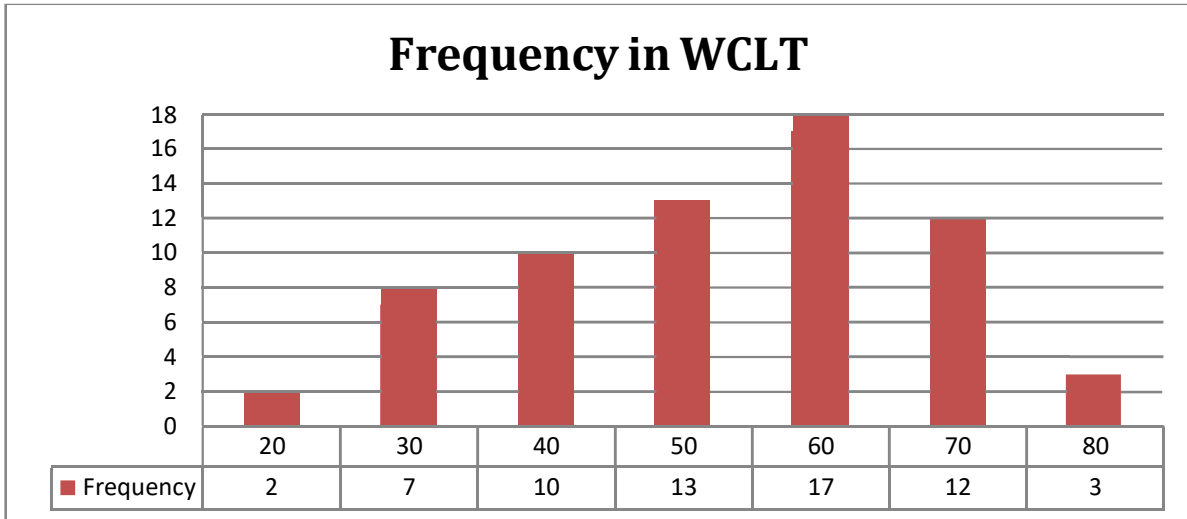
Fig. 18. Frequency on WCLT within different range of distance

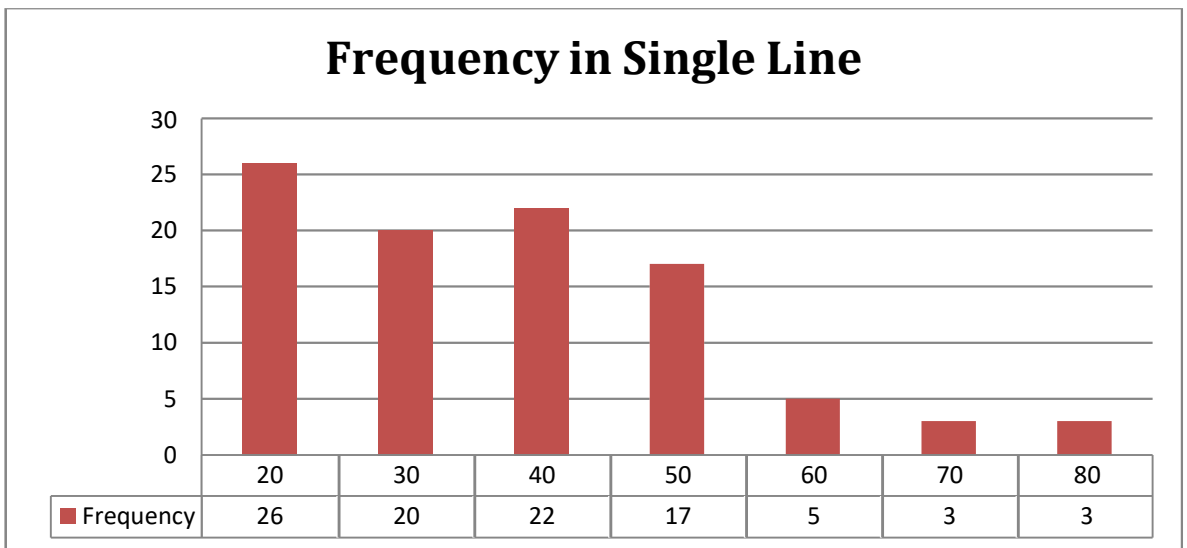
Fig. 19. Frequency on single line within different range of distance

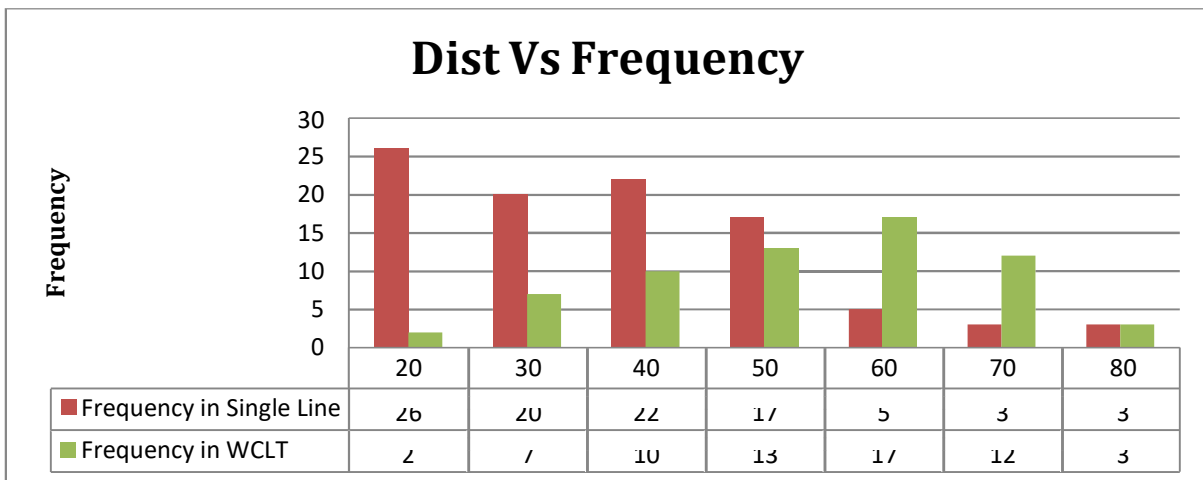
Fig. 20. Comparative analysis of driving behavior on both single line and WCLT within different range of distance

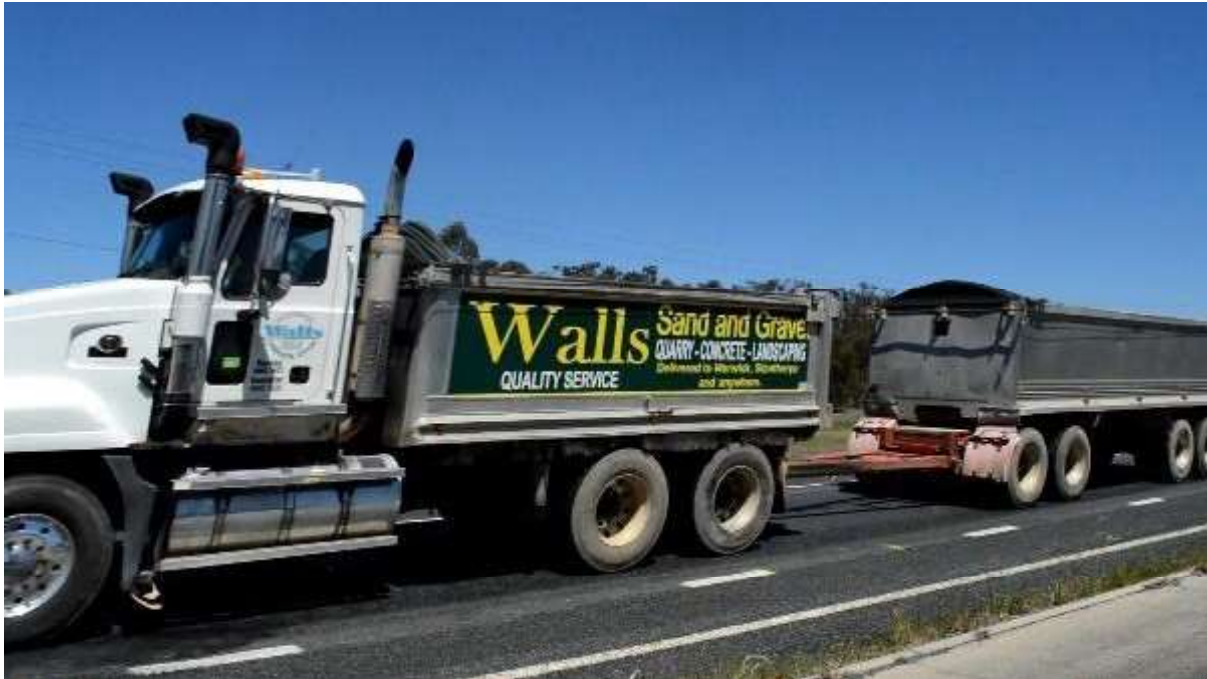
Fig. 21. Driver Behaviour on WCLT (Distance from Shoulder = 50.6 cm)

Figures 21 to 24 show some examples of driving behaviour in Warwick sites. From the images, it is clear that, while there is WCLT, drivers feel more comfortable on driving closer to WCLT, while in the case of single line drivers mostly drive closer to the shoulder line. Although, the behaviour is not obvious for all drivers, there are some cases where driving behaviour changes. But our overall observation and collected samples show that, in most of the cases, driver behaviour follows the first scenario.

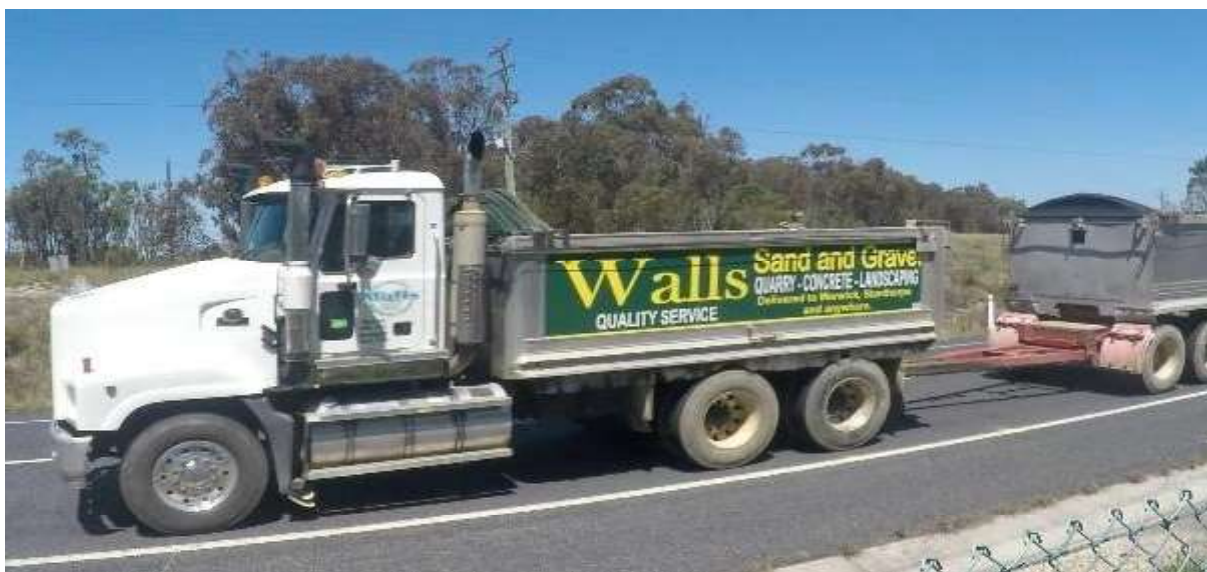
Fig. 22. Driver Behaviour on Single Line (Distance from Shoulder = 20.4 cm)

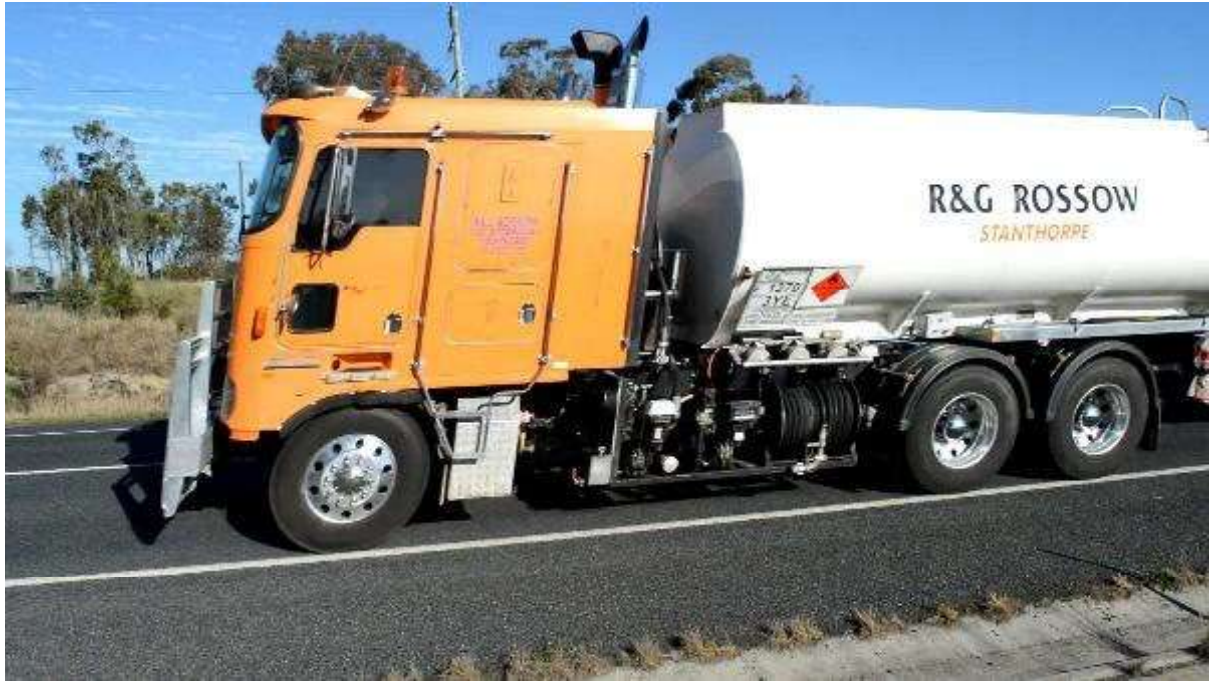
Fig. 23. Driver Behaviour on Single Line (Distance from Shoulder = 2 cm)

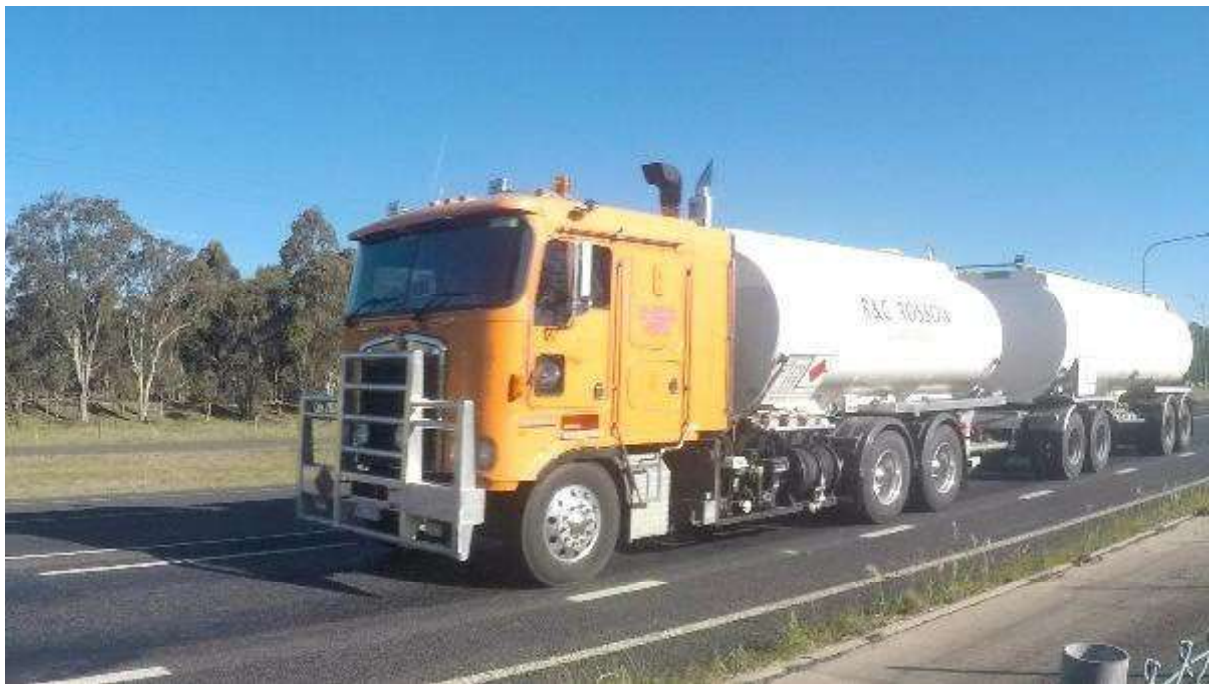
Fig. 24. Driver Behaviour on WCLT (Distance from Shoulder = 32.4 cm)

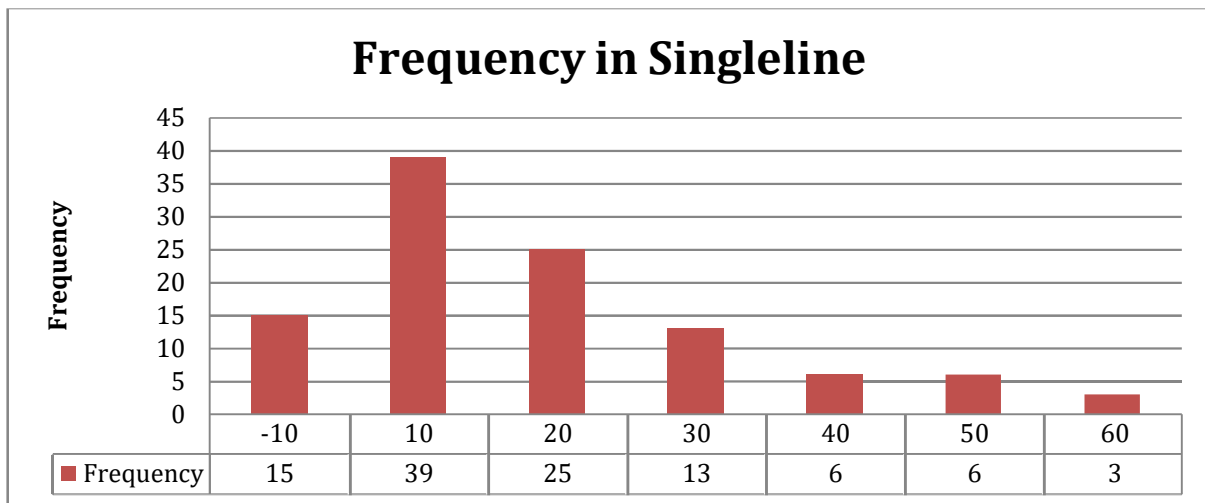
Fig. 36. Frequency on single line within different range of distance

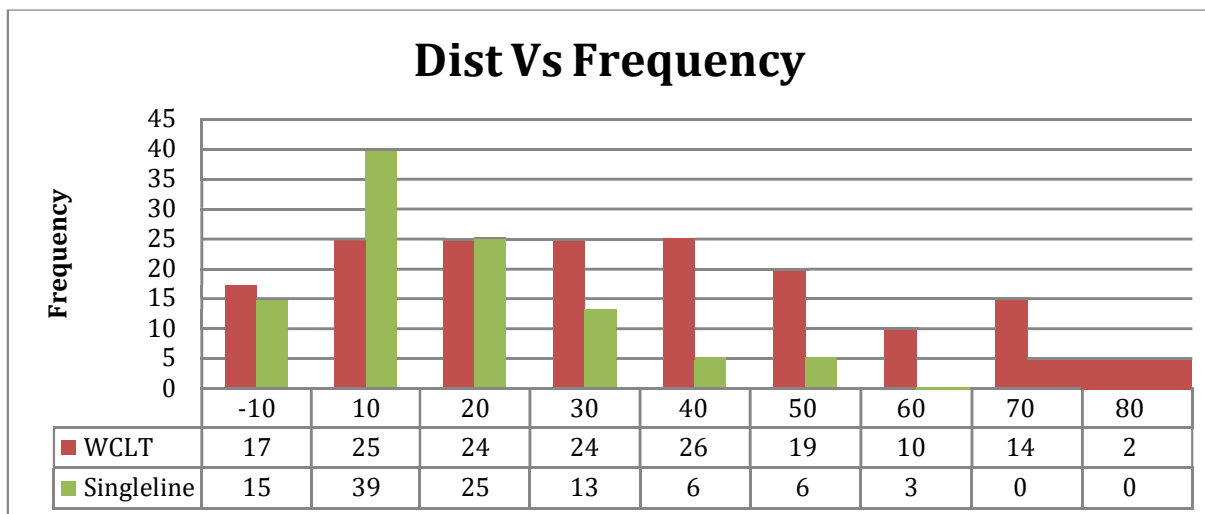
Fig. 38. Comparative analysis of driving behaviour on both single line and WCLT within different range of distance
